**CORROSION CONDITION SURVEY  
OF U1020 MONTANA AVENUE OVERPASS-BILLINGS  
FOR  
MONTANA DEPARTMENT OF TRANSPORTATION  
WJE No. 2000.2547  
November 27, 2000**

CORROSION CONDITION SURVEY  
OF U1020 MONTANA AVENUE OVERPASS-BILLINGS  
FOR  
MONTANA DEPARTMENT OF TRANSPORTATION  
WJE No. 2000.2547  
November 27, 2000

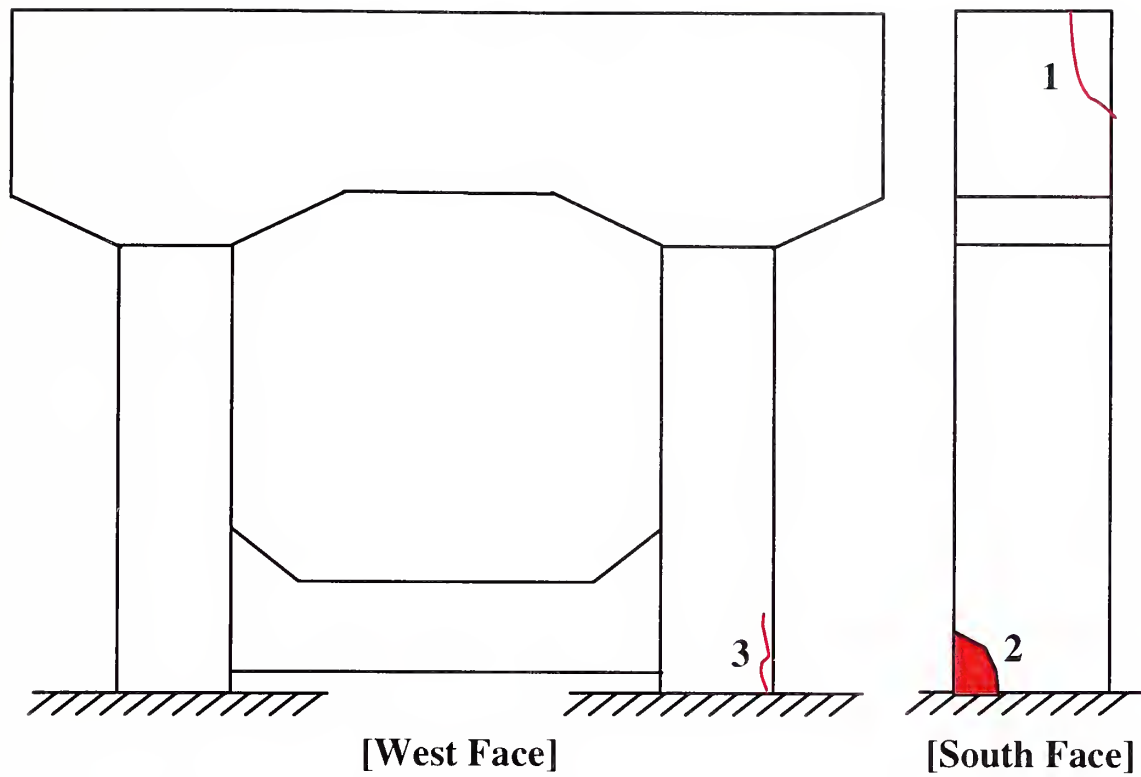
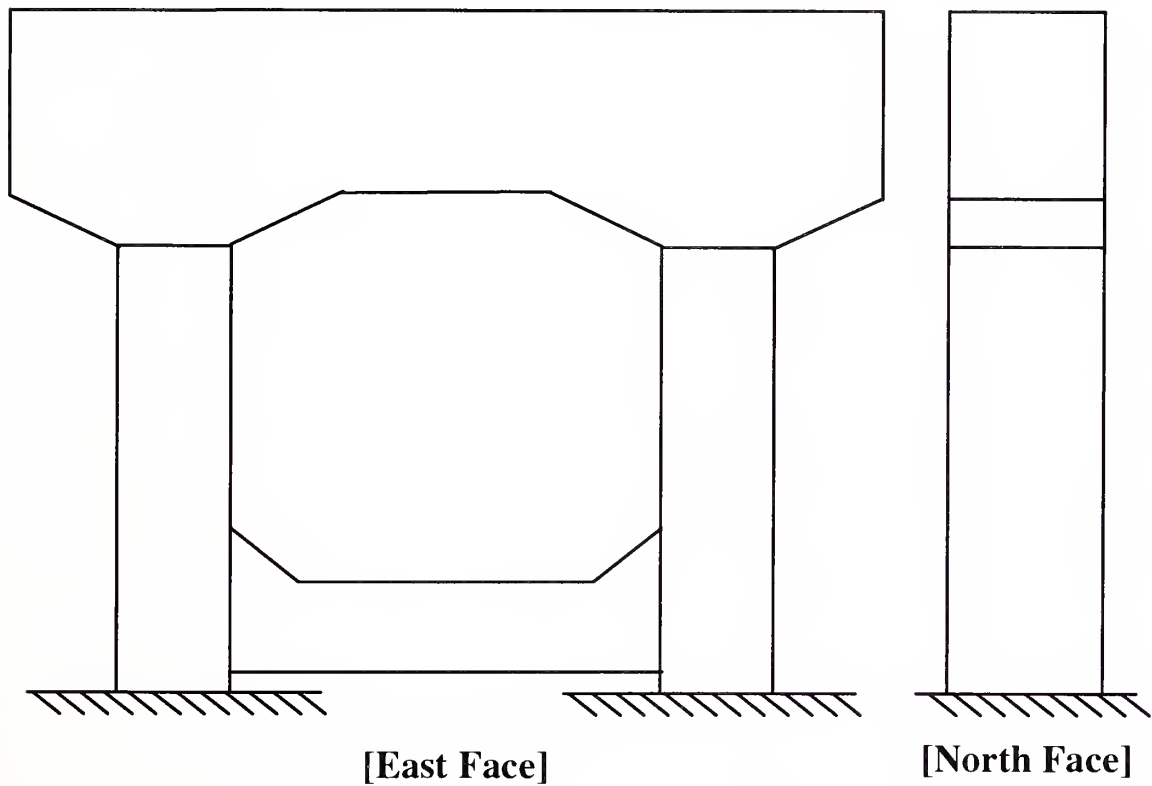
Figure 55A. Condition of Bent No. 25 (West Bound).

Damage	Location	Face	Description of Damage (No.)	Leakage Condition: No Leakage
	Cap	South	A crack (1)	
	S. Col.	West	Spall and freeze-thaw damage (2)	
	S. Col.	West	A crack (3)	Test Performed: None

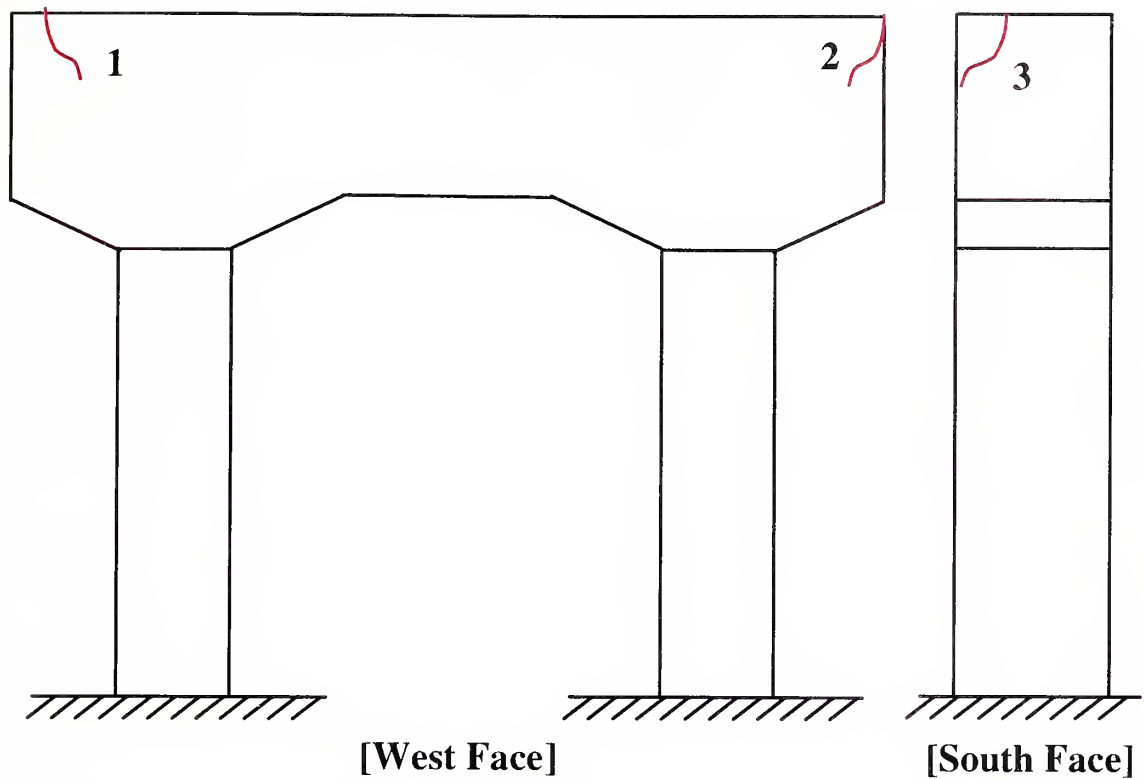
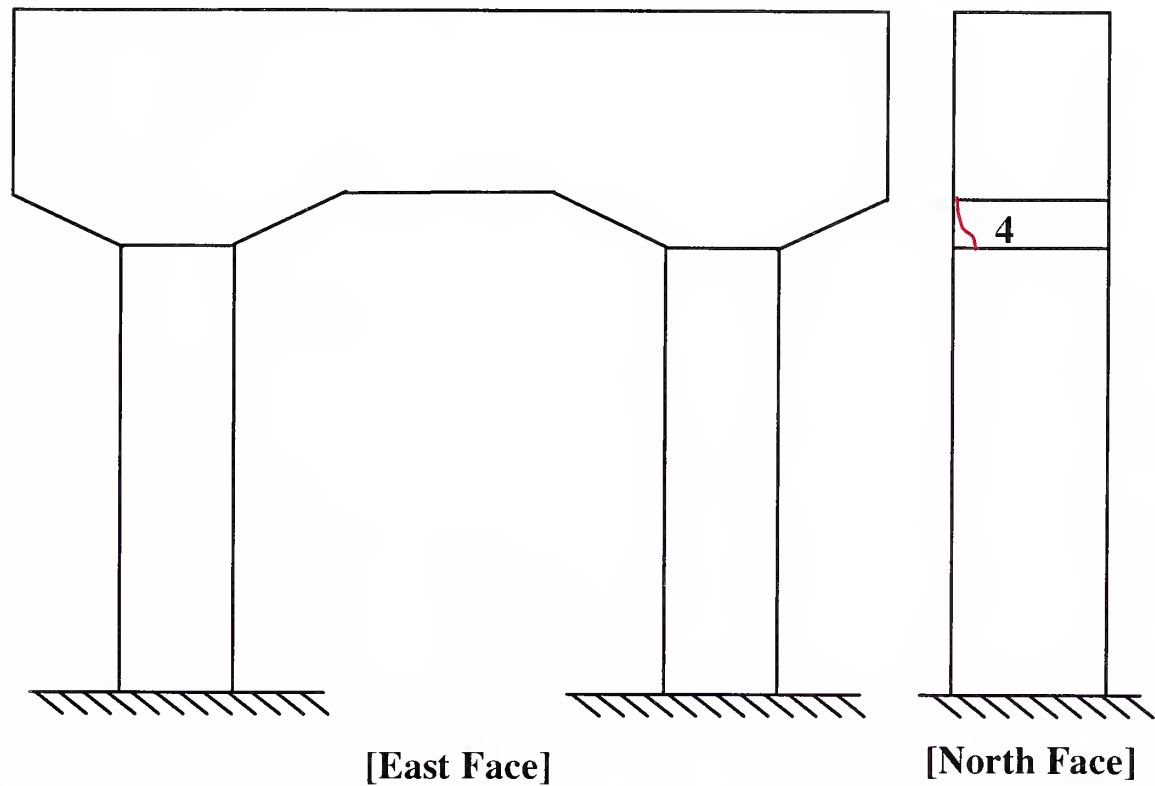
**Figure 57A. Condition of Bent No. 27 (West Bound).**

Damage	Location	Face	Description of Damage (No.)	Leakage Condition: No leakage but dry stains  Test Performed: None
	Cap	West	A crack (1)	
	Cap	West	A crack (2)	
	Cap	South	A crack (3)	
	Cap	North	A crack (1)

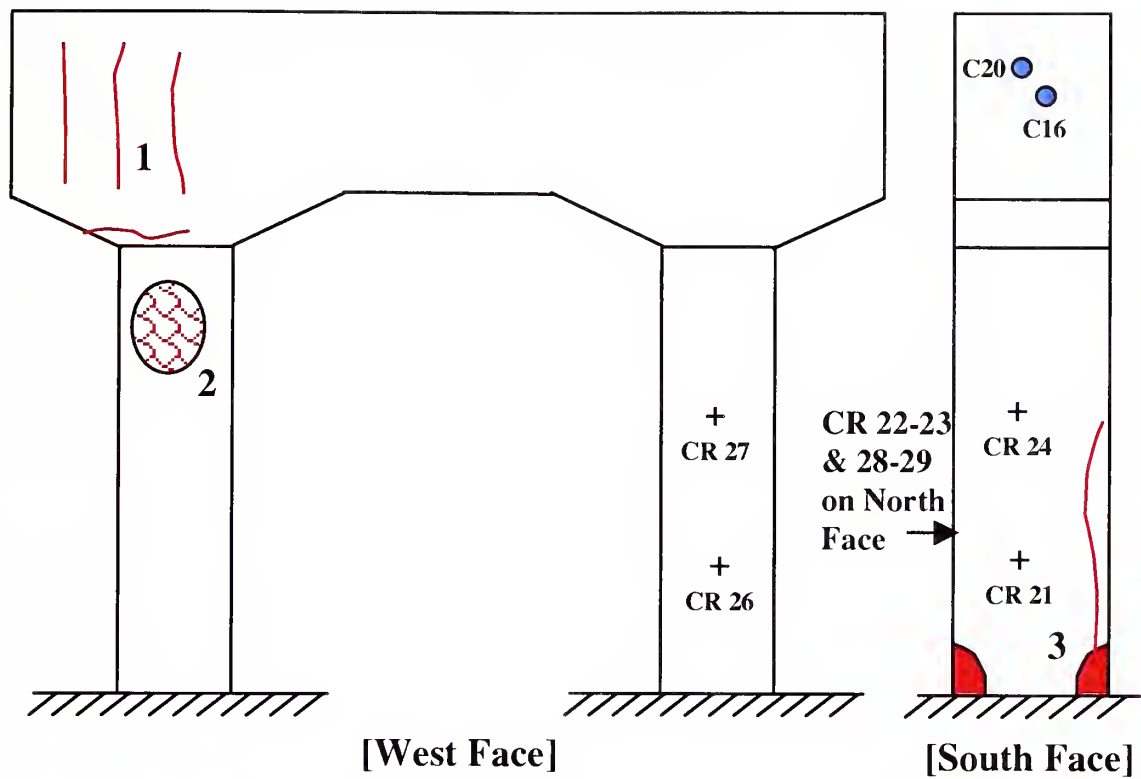
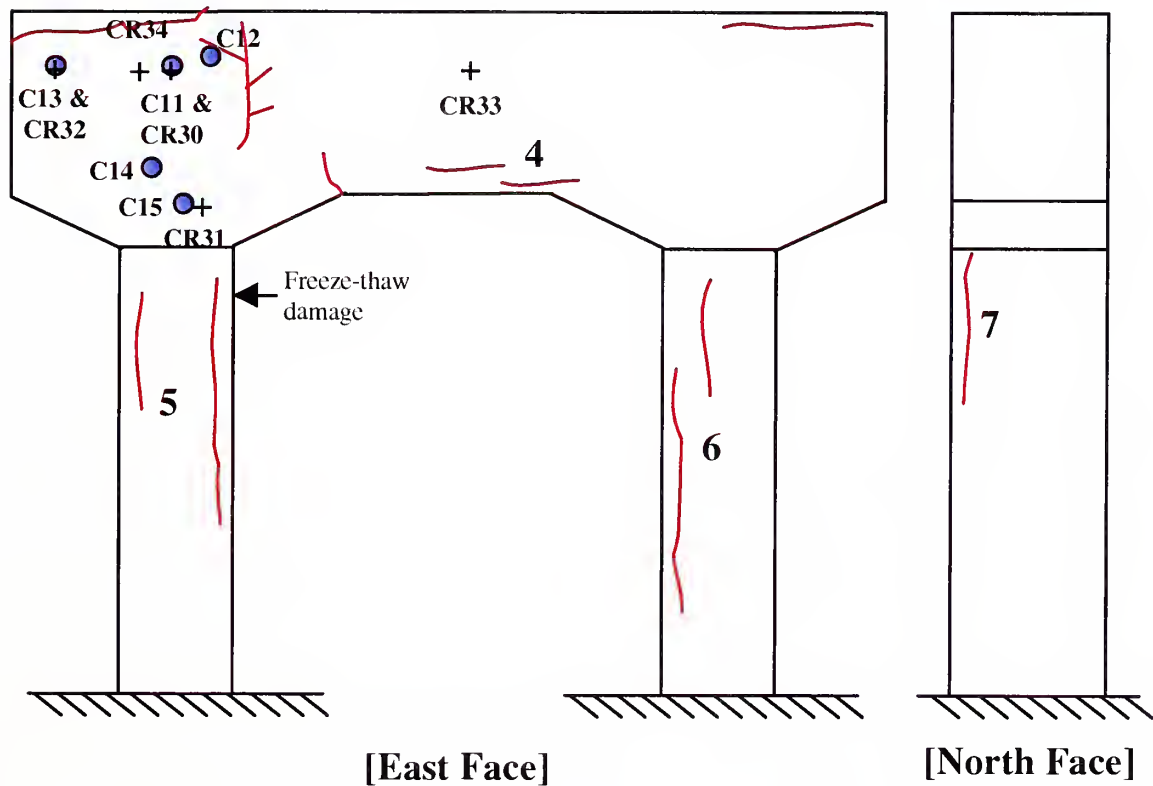
**Figure 58A. Condition of Bent No. 28 (West Bound).**

Damage	Location	Face	Description of Damage (No.)	Leakage Condition: Active leakage under beams 2-5  Test Performed: - CR 21-24 & 26-34 - Cores 11-16 & 20 - Carbonation Test at 3
	Cap	West	Four cracks (1)	
	N. Col.	West	Pattern cracking (2)	
	S. Col.	South	Two spalls and a crack (3)	
	Cap	East	Six cracks (4)	
	S. Col.	East	Two cracks (5)

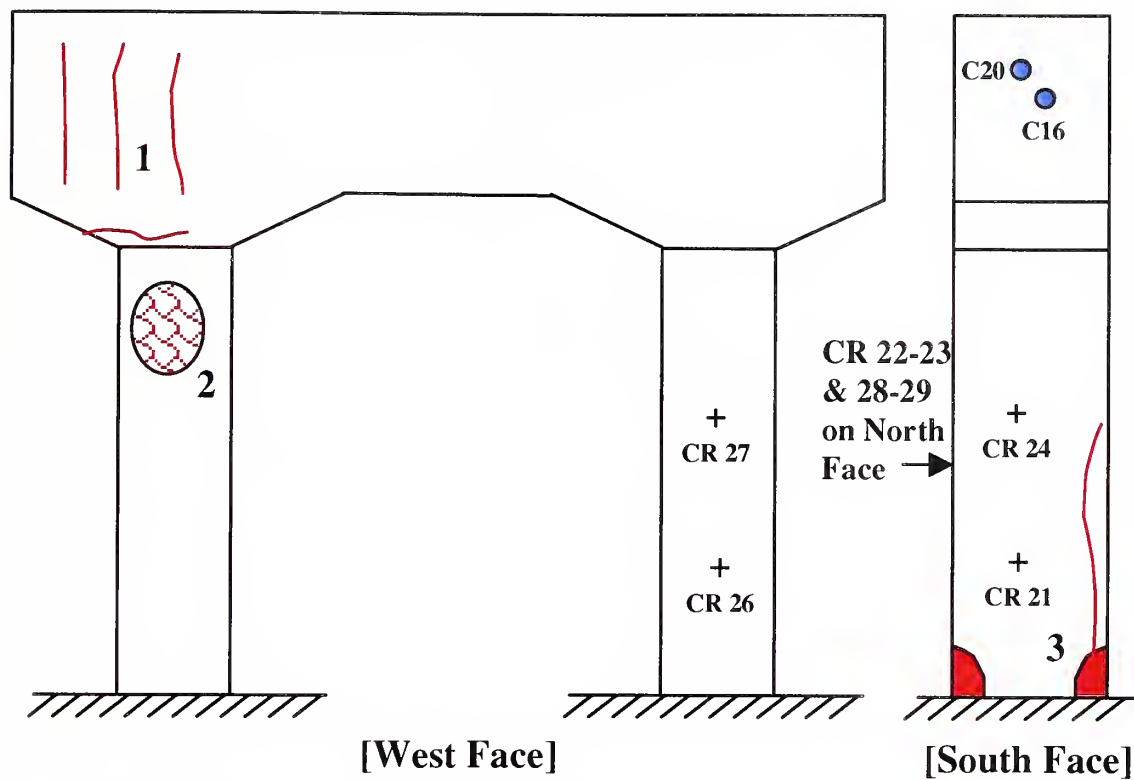
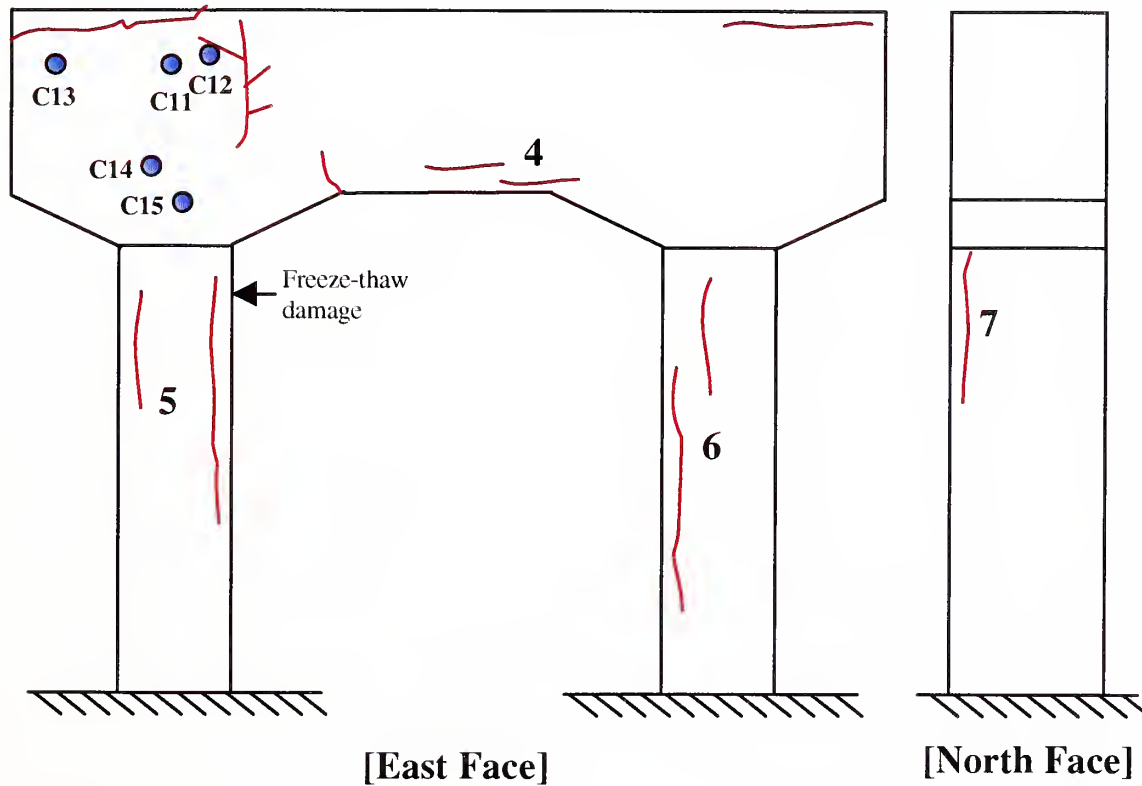
**Figure 59A.1. Condition of Bent No. 29 (West Bound) - To Be Continued.**

Damage	Location	Face	Description of Damage (No.)	Leakage Condition: Active leakage under beams 1-5 (3-5 worst)  Test Performed: - CR 21-24 & 26-29 - Cores 11-16 & 20 - Carbonation Test at 3
	N. Col.	East	Two cracks (6)	
	N. Col.	North	A crack (7)

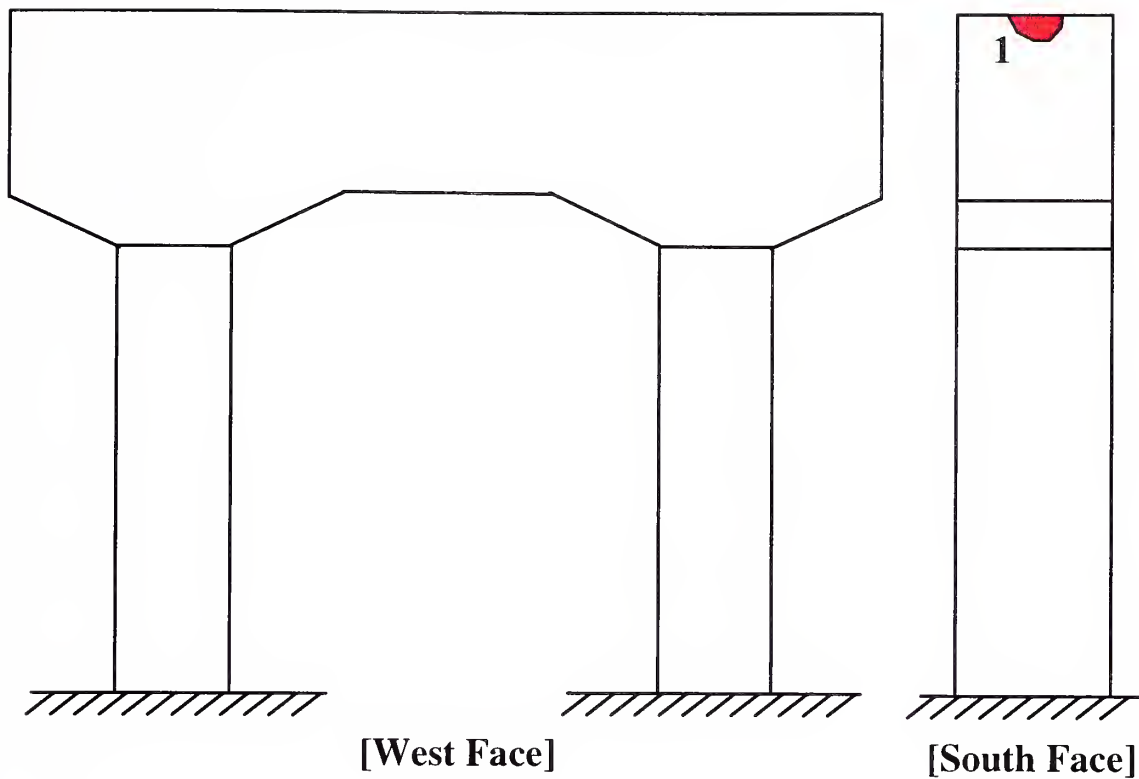
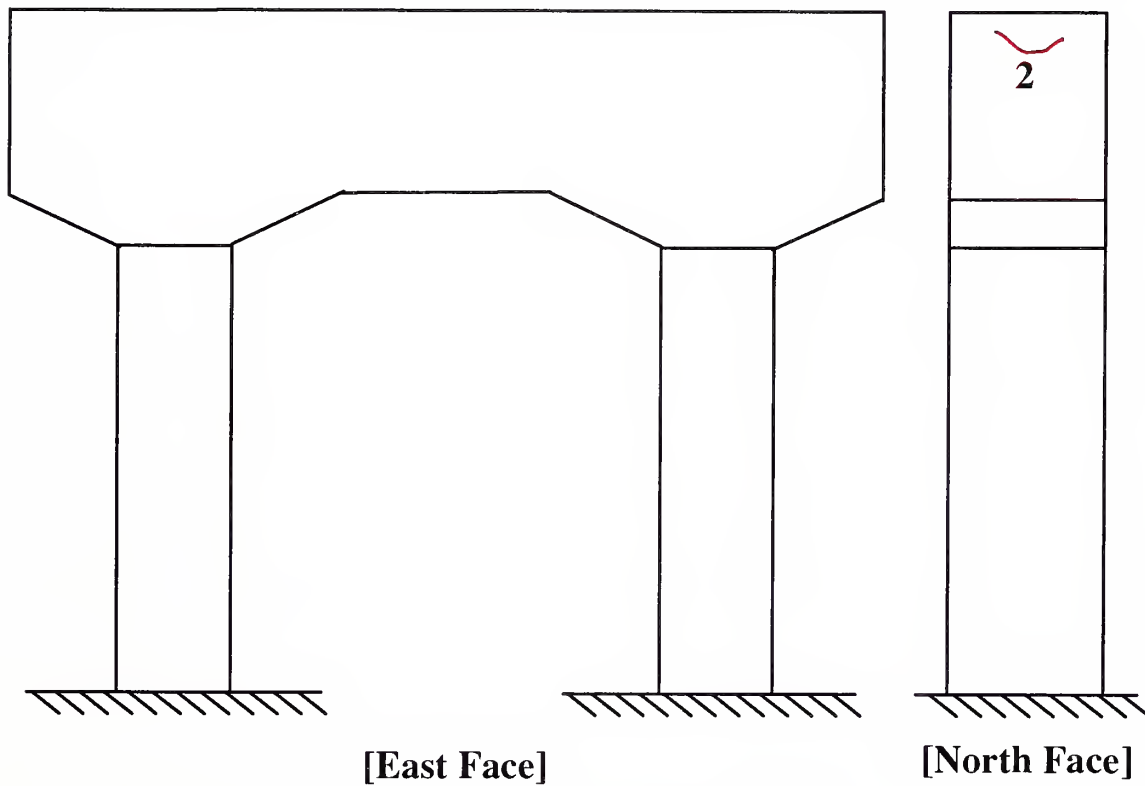
**Figure 59A.2. Condition of Bent No. 29 (West Bound) - Continued.**

Damage	Location	Face	Description of Damage (No.)	Leakage Condition: No leakage but dry stains
	Cap	South	Small spall (1)	
	Cap	North	A crack (2)	
				Test Performed: None

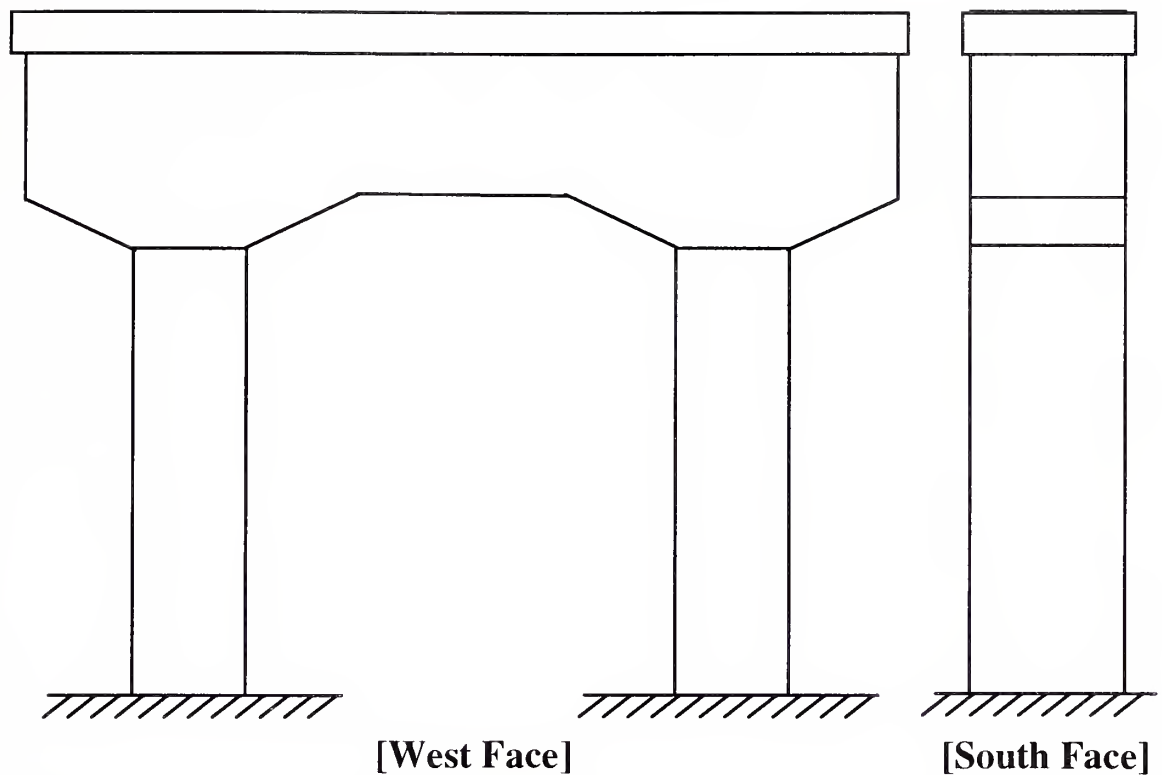
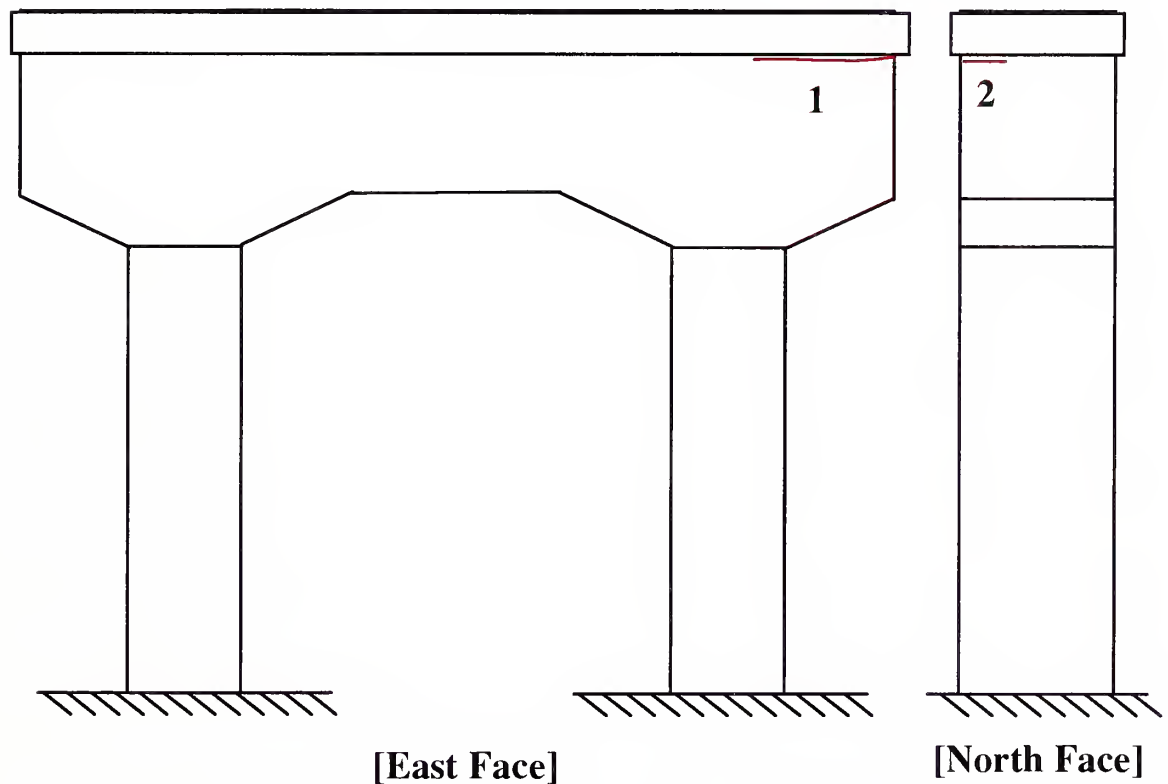
**Figure 60A. Condition of Bent No. 30 (West Bound).**

Damage	Location	Face	Description of Damage (No.)	Leakage Condition: Active leakage below beams 1-4  Test Performed: None
	Cap	East	A crack (1)	
	Cap	North	A crack (2)

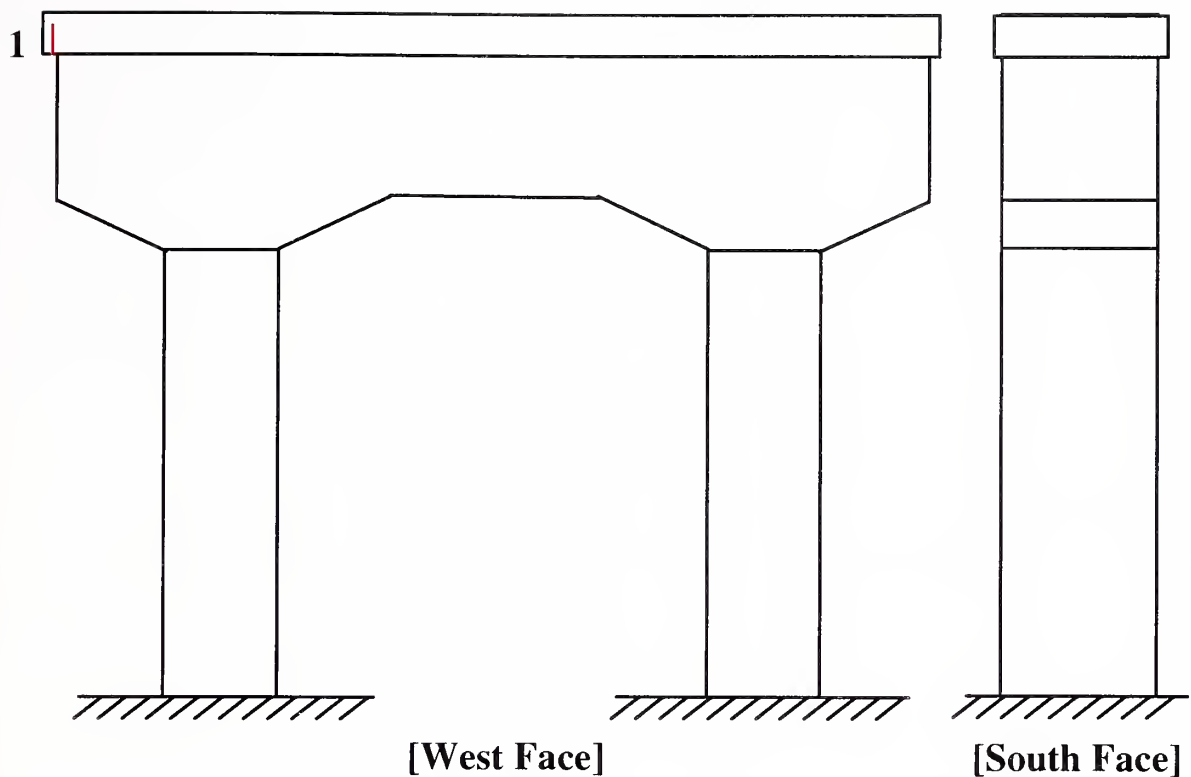
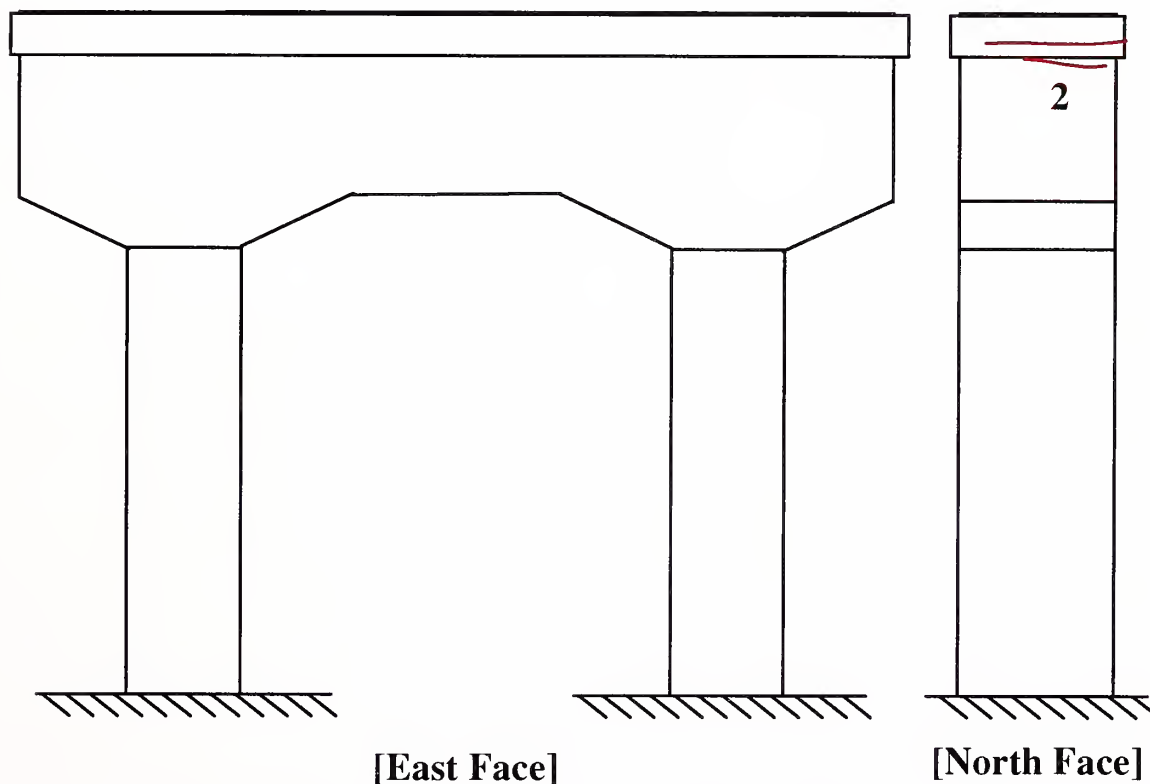
Figure 61A. Condition of Bent No. 31 (West Bound).

Damage	Location	Face	Description of Damage (No.)	Leakage Condition: No leakage but moist below beams 1-2  Test Performed: None
	Cap	West	A crack on top cap (1)	
	Cap	North	Cracks on top cap and underside(2)

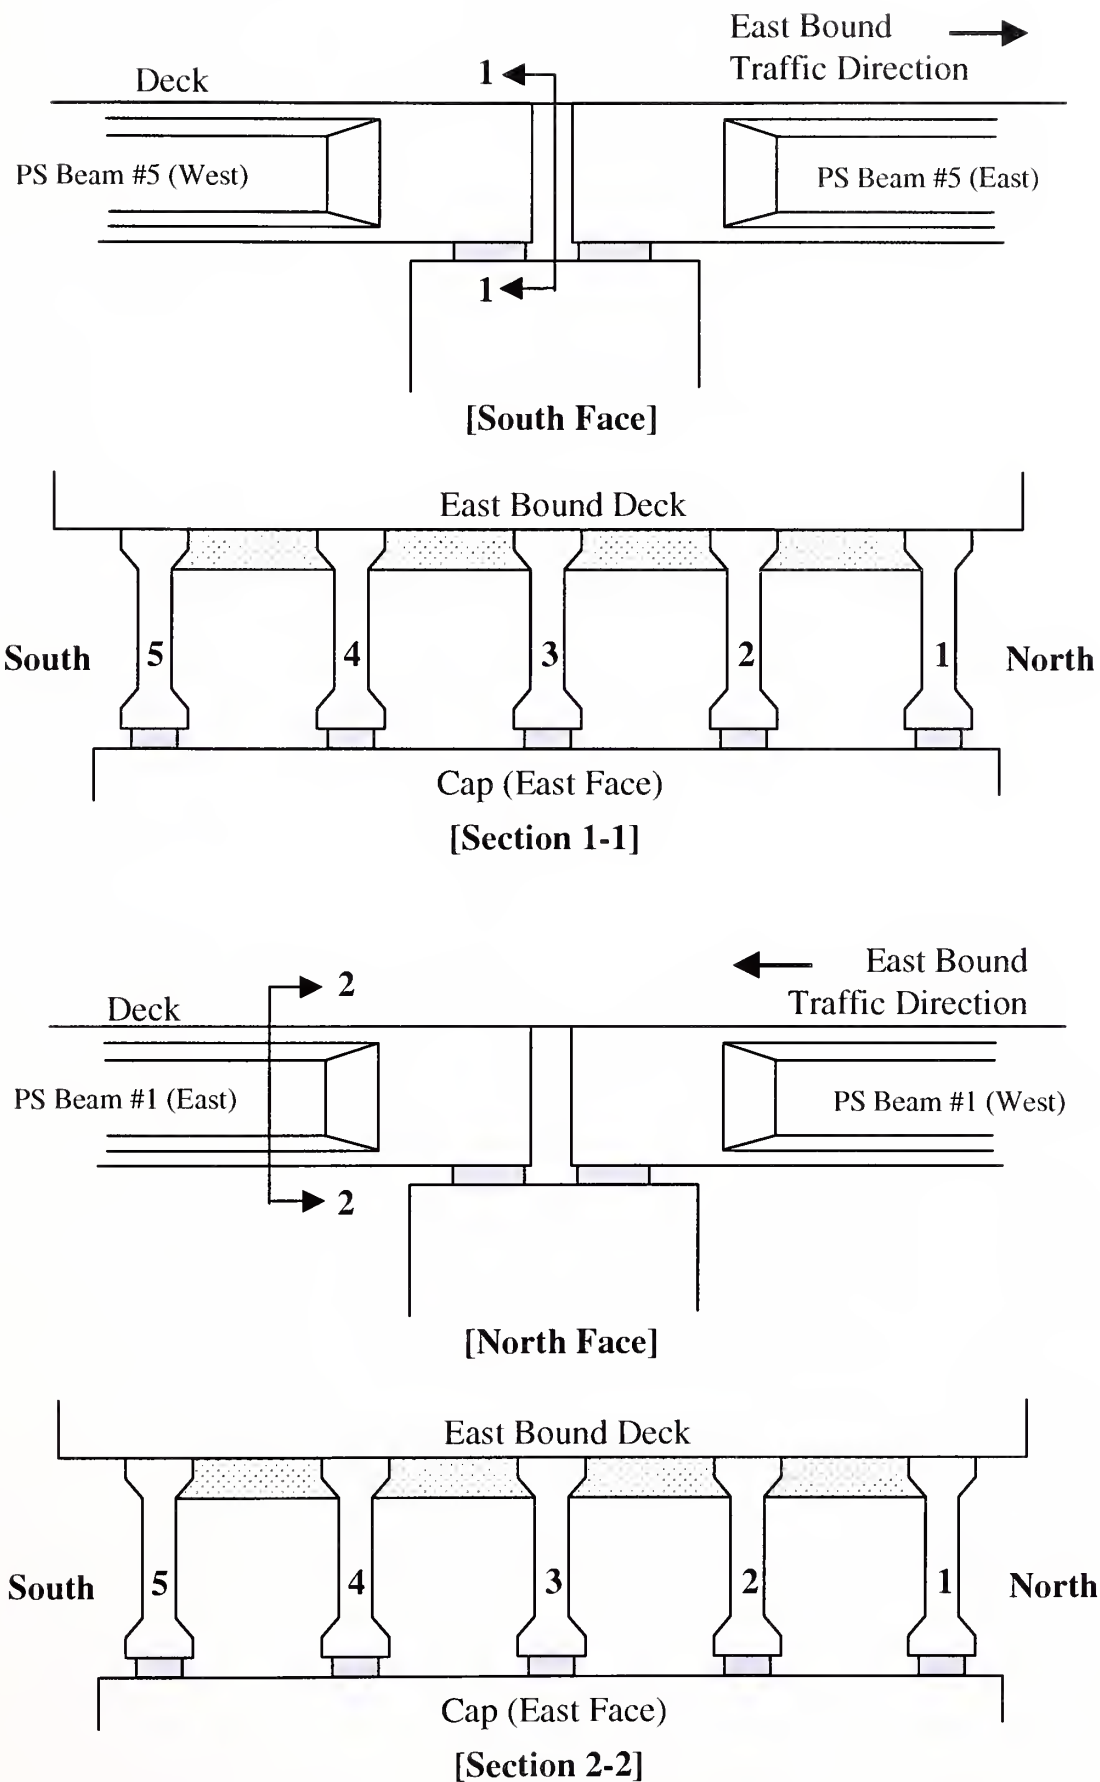
**Figure 21B. Condition of Beam Joints over Bent No.22 (East Bound).**

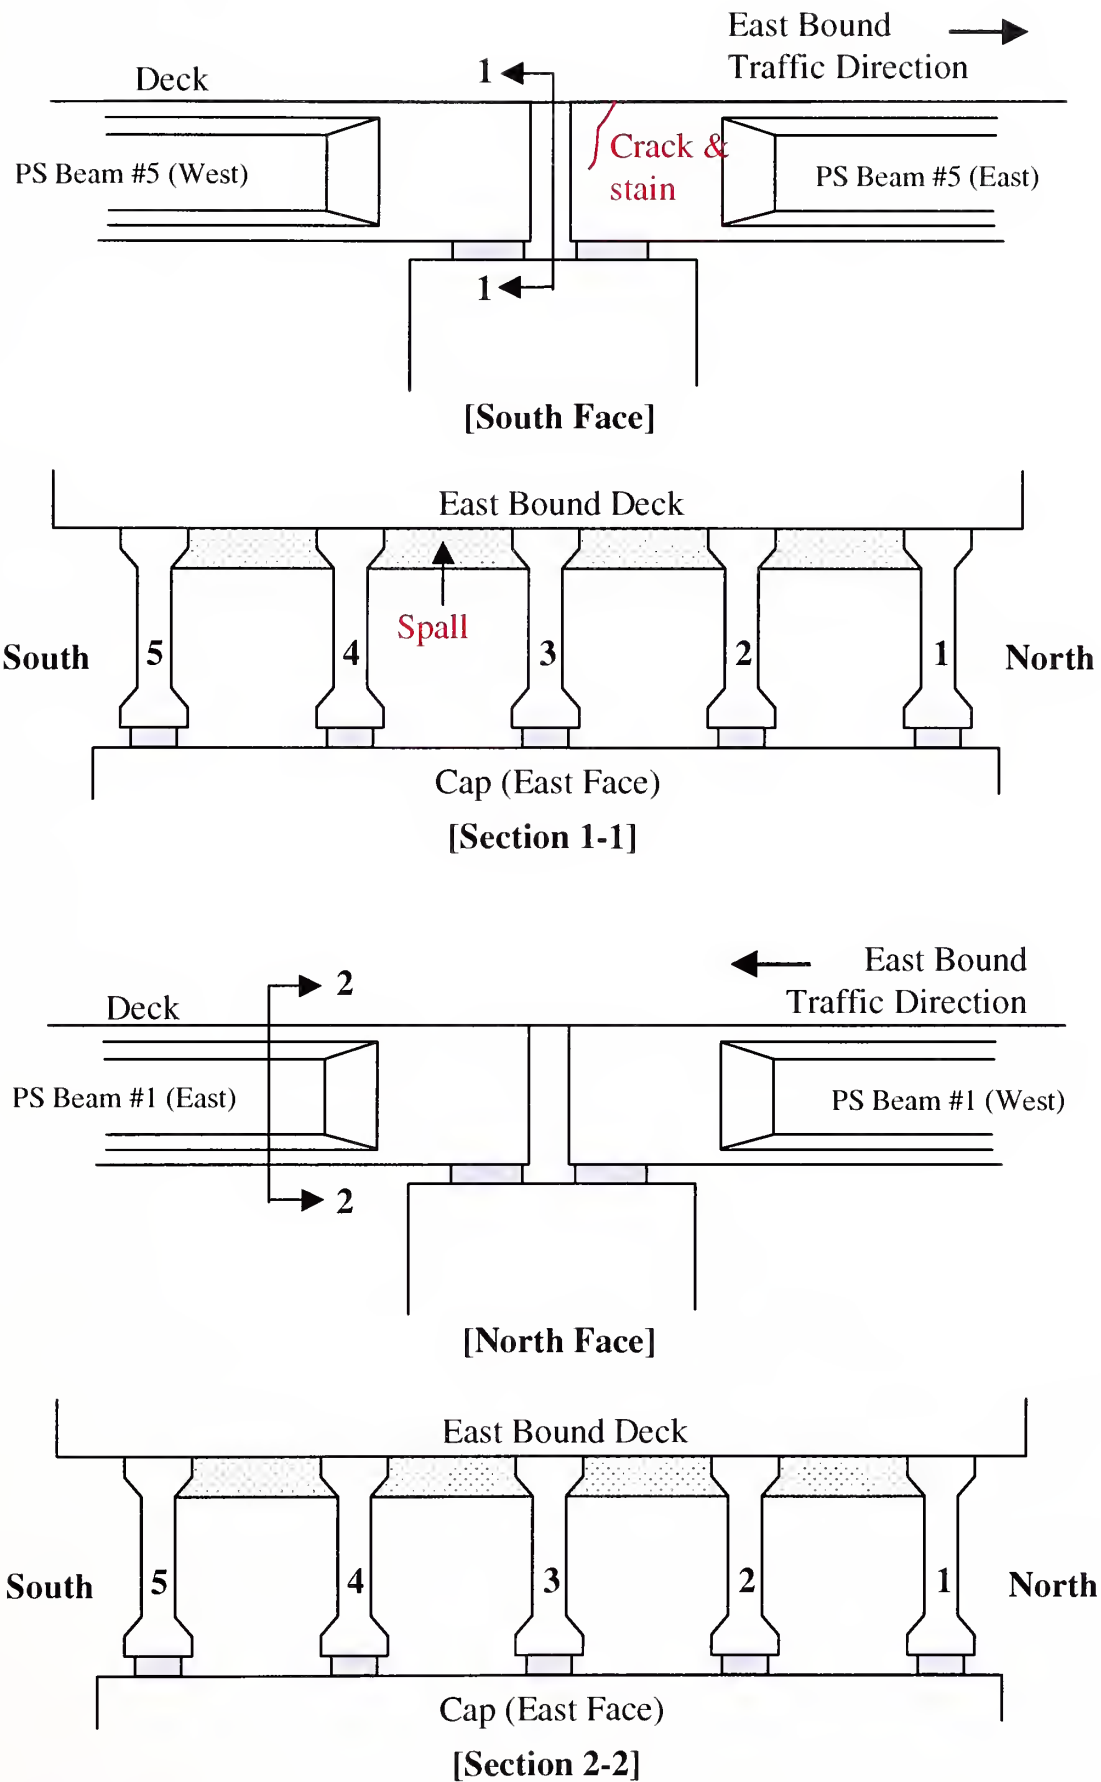
Figure 22B. Condition of Beam Joints over Bent No. 23 (East Bound).

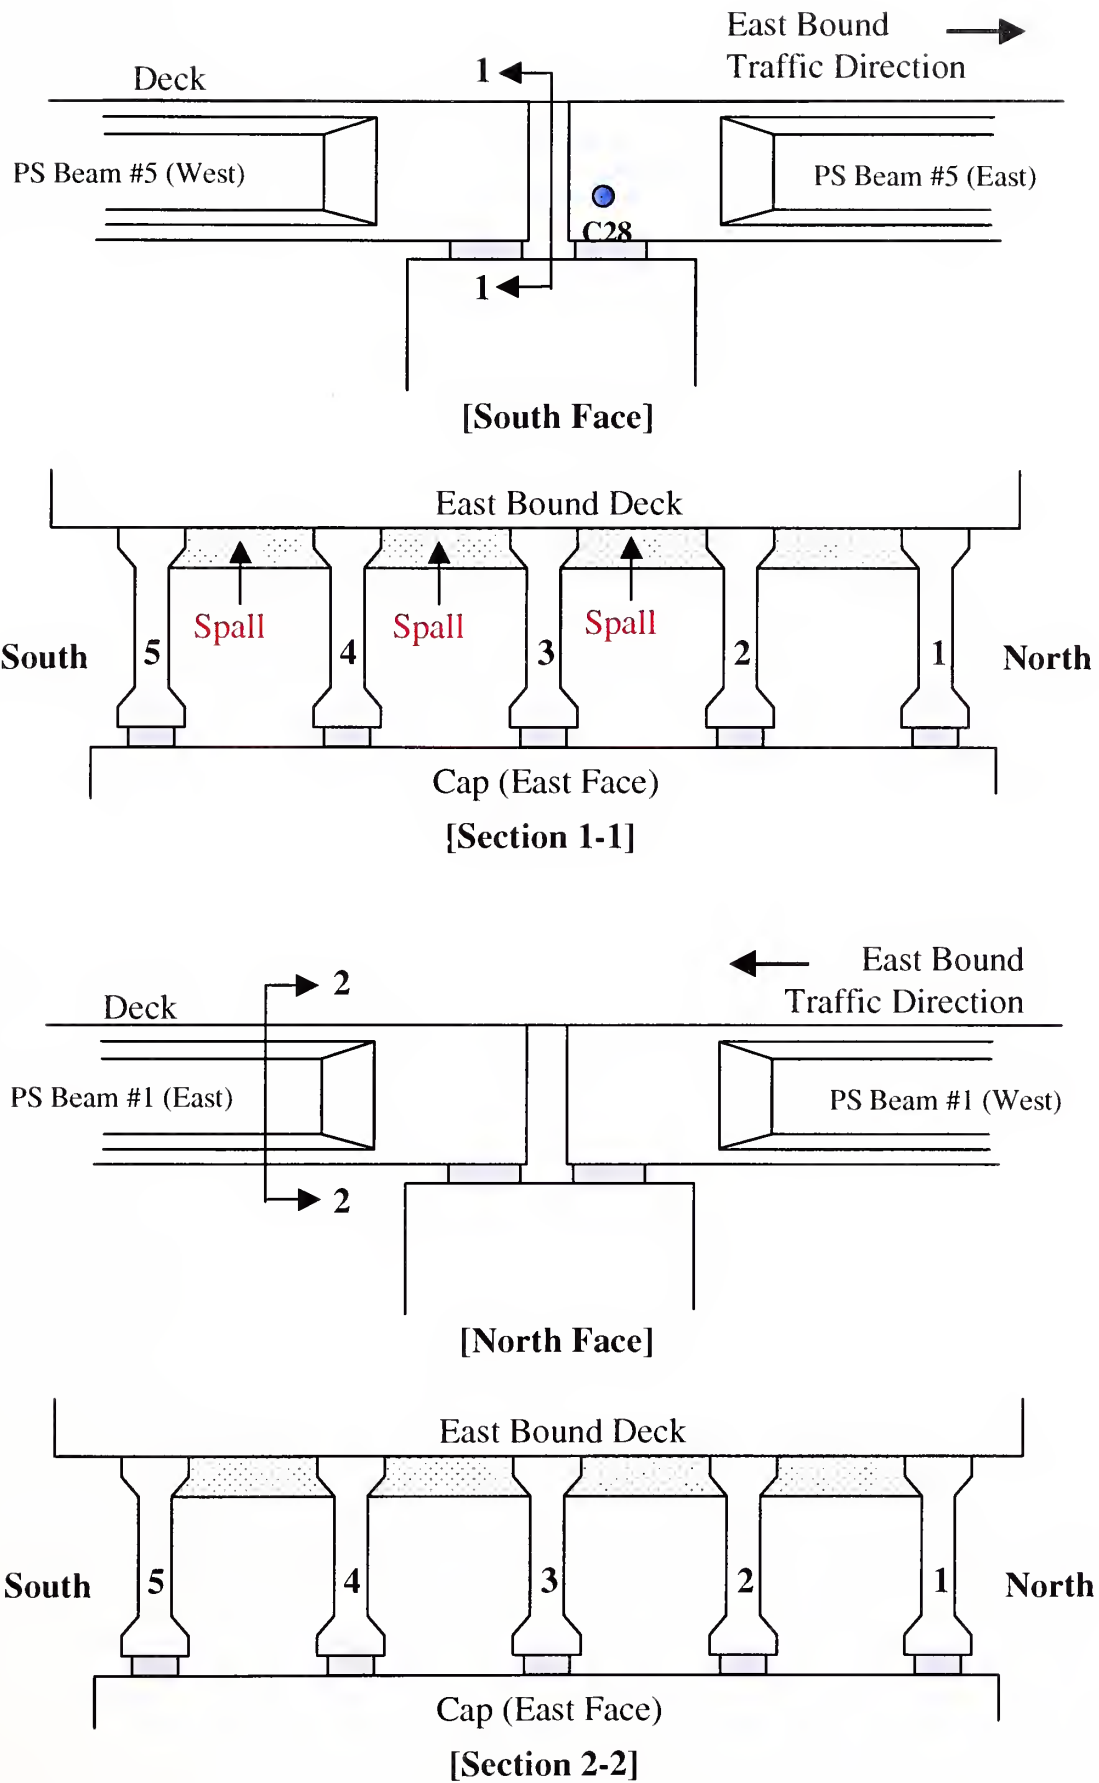
**Figure 23B. Condition of Beam Joints over Bent No. 24 (East Bound).**

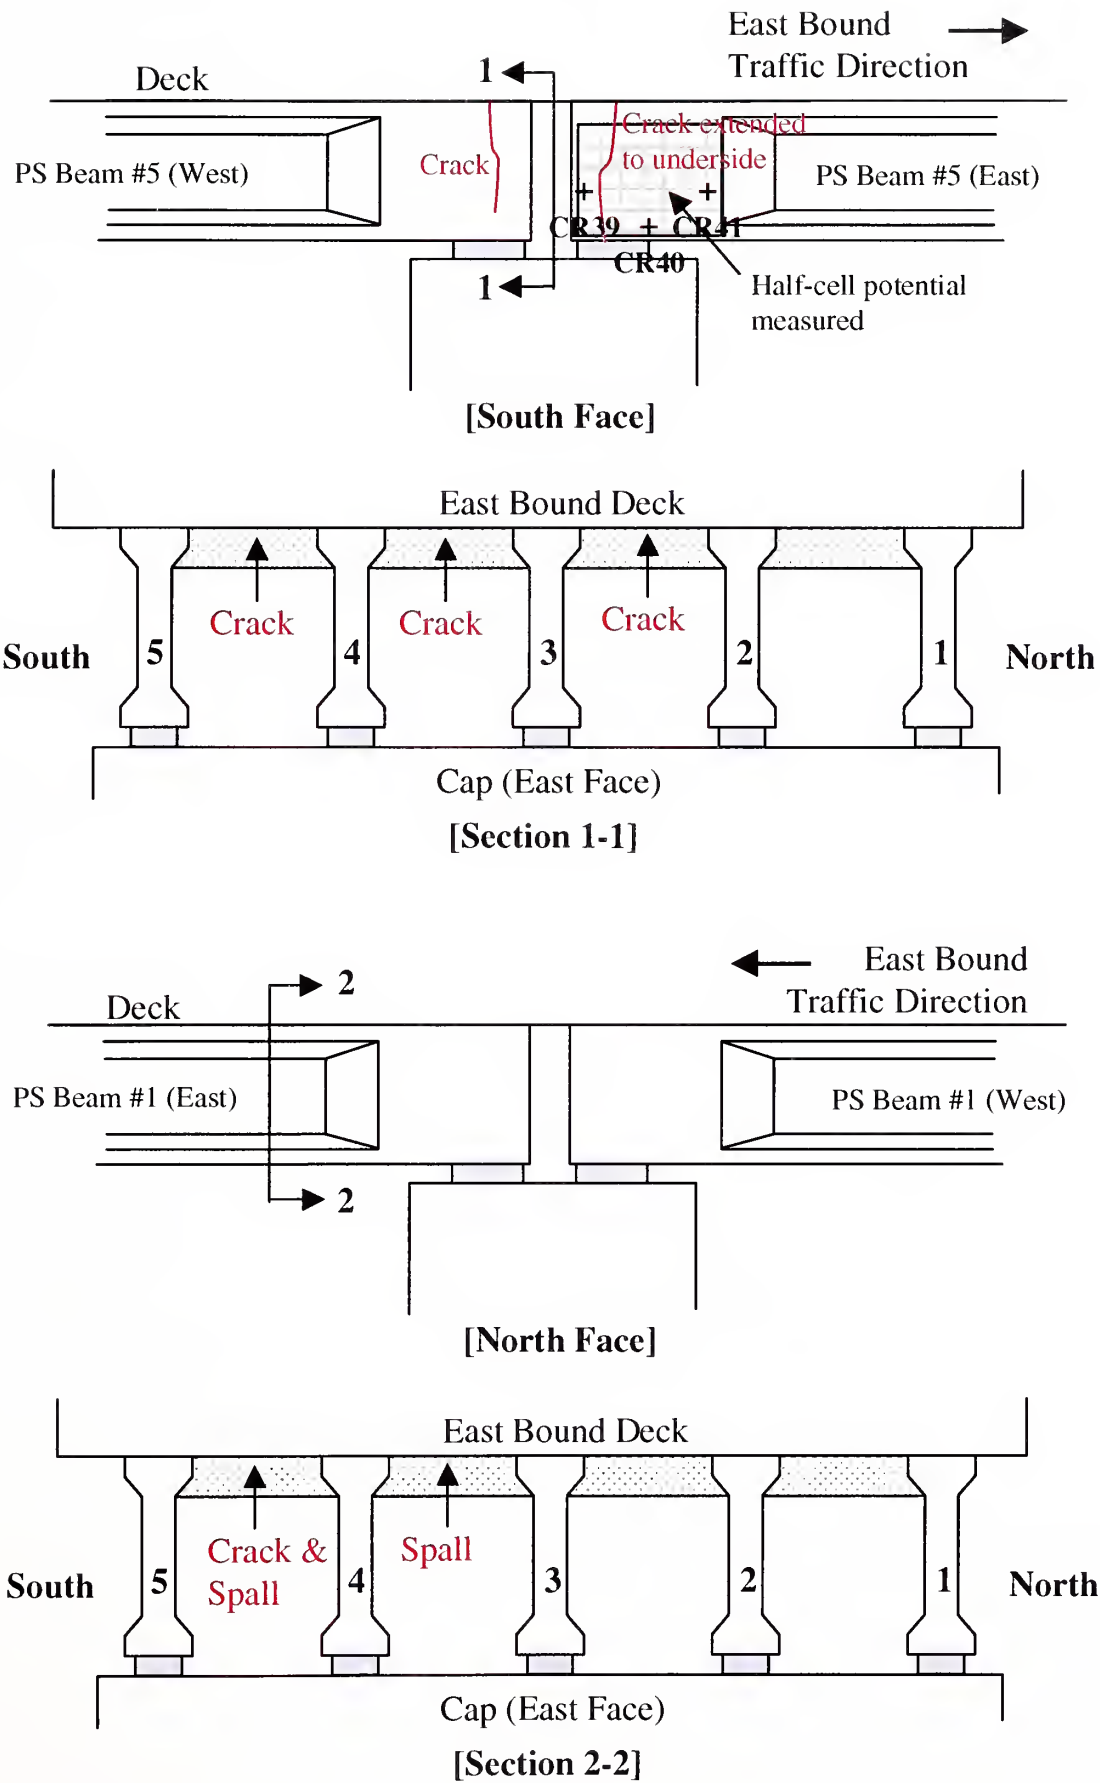
Figure 24B. Condition of Beam Joints over Bent No. 25 (East Bound).

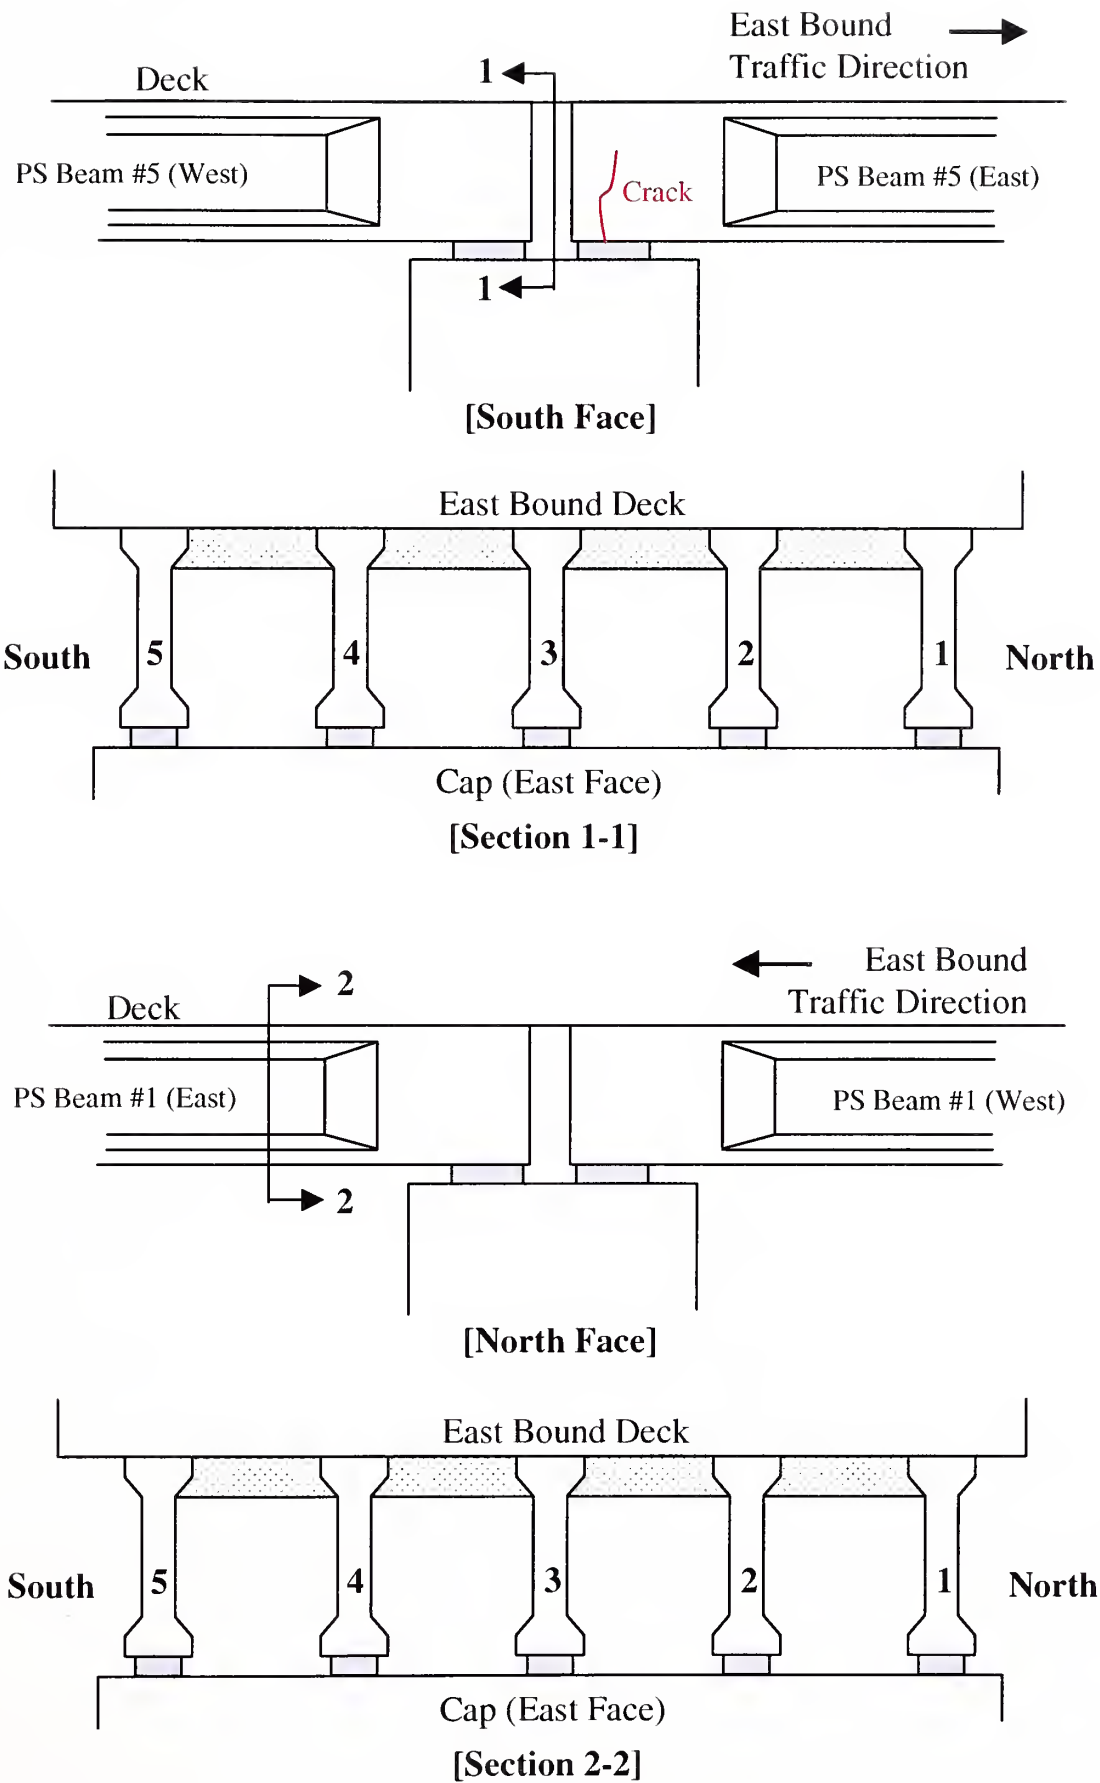
**Figure 25B. Condition of Beam Joints over Bent No. 26 (East Bound).**
